STRUCTURAL COLLAPSE OF REINFORCED CONCRETE BUILDINGS: AN ASSOCIATION BETWEEN OVERLOADS AND PATHOLOGIES

ABSTRACT

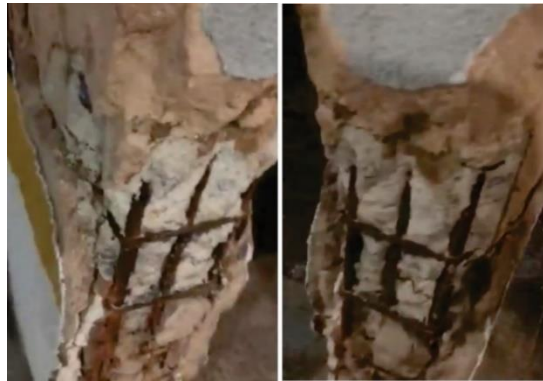
As previously mentioned, the building was in a precarious structural condition and was not maintained. It presented several pathologies, such as cracks, columns with exposed reinforcement, and high levels of corrosion, as shown in Figure 1. Besides, it did not have the inspection certificates attesting to its structural maintenance.

Figure 1 – Exposed column reinforcements

According to Tavares (2019), it was possible to observe that a covering of the structural steel had been made in some pillars by applying a layer of plaster, which does not serve as a structural material. The author also states that such pillars had already suffered previous interventions, where the oxidized steel did not undergo an adequate treatment to fulfill its function in that structural system. Figure 1, shown above, presents the situation of one of the pillars before the collapse.

In this aspect, it can be seen that those responsible for the maintenance of the Andrea Building neglected essential standards for reinforced concrete buildings, such as NBR 6118, by maintaining the steel at a high level of corrosion and applying plaster coating where there should be concrete to resist compression efforts, and NBR 5674 (ABNT, 2012), which deals with housing maintenance, as well as other standards mentioned before. The company and the service provider hired for the maintenance that was occurring in the building on the day of the collapse, in turn, did not comply with the

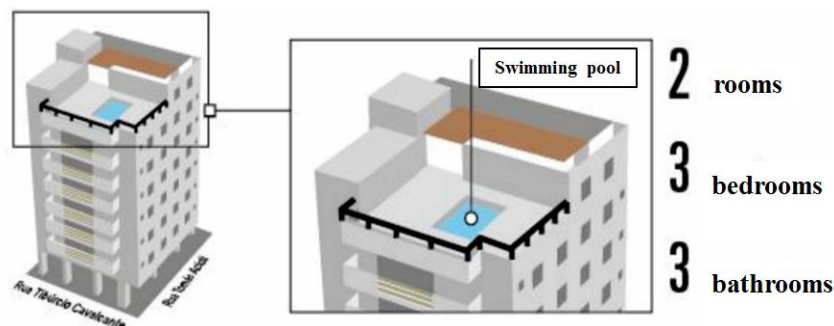
After its construction was finished, the Andrea Building was overloaded on the roof floor, as shown in Figure 2. Two living rooms, three bedrooms, and three bathrooms were built where previously it was an open area, and the construction of these rooms occupied an area of approximately 60 m². This overload contributed to the reduction of the building's global safety factor. In this aspect, it is very important to highlight that, to make modifications in the structure of a building, in general, it is necessary to redo the structural project and check the structural stability of the building, which did not occur in the Andrea Building.

Figure 2 – Modifications to the building's roof

The increase in the load on the structural elements of the Andrea Building during its life was due to the overload due to the construction of elements not foreseen in the project: the reform carried out on the roof of the building, in which several rooms that were not foreseen in the original project were executed; and the construction actions: the reformulation of the roof caused loads that were not considered in the original project.

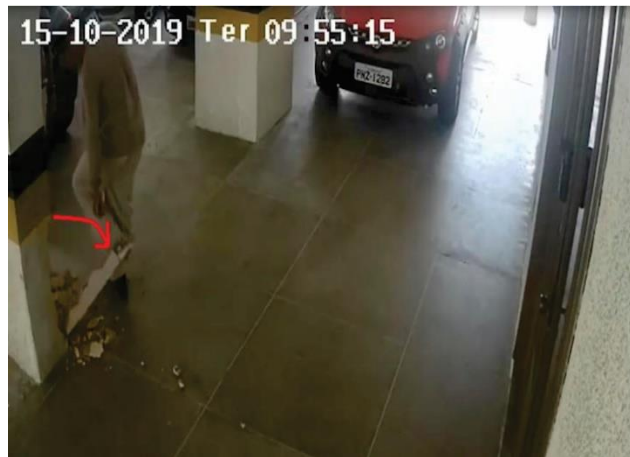
of the reinforcement done wrongly at the time of its construction. Besides, it was also found that the loss of the columns' section was one of the fundamental factors for the collapse since they had their compressive strength was compromised by the alteration of the distribution of structural loads. Furthermore, there were superficial deformation treatments, such as in the execution of the plastering, which presented flaws throughout the building and were deteriorating, as shown in Figure 3.

Figure 3 – Intervention made in the pillars

Several pathological manifestations can be pointed out as compromising the resistant capacity of the building's columns: the reinforcement corrosion: the oxidation of the reinforcement of the columns observed and highlighted by Tavares (2019), a phenomenon that compromises the strength of the material; the segregation of concrete materials: the columns had deep segregation of materials, exposing the reinforcement, increasing its oxidation, and compromising the solidarity between concrete and steel of the structural element; and the covering of plaster instead of concrete: due to the segregation of the column concrete and its peeling, it was observed that the reinforcement of the columns was covered with plaster where there should be a concrete cover of at least two centimeters, according to NBR 6118, which shows that interventions were performed before the collapse incorrectly.
