REHABILITATION OF CONCRETE INDUSTRIAL BUILDING FACADES ATTACKED BY ACIDS

This case study was based on the project for rehabilitation of sealing of facades, built in precast concrete, an industrial plant galvanizing of steel structures. Analysis of the Brazilian Standard NBR 6118 (design of reinforced concrete) was taken as well as review of literature on durability to identify causes of pathologies and prescribe the best therapy with the most appropriate materials and techniques. It was noticed that the main agents are aggressive chlorides and epoxy is the most suitable material that recovery.

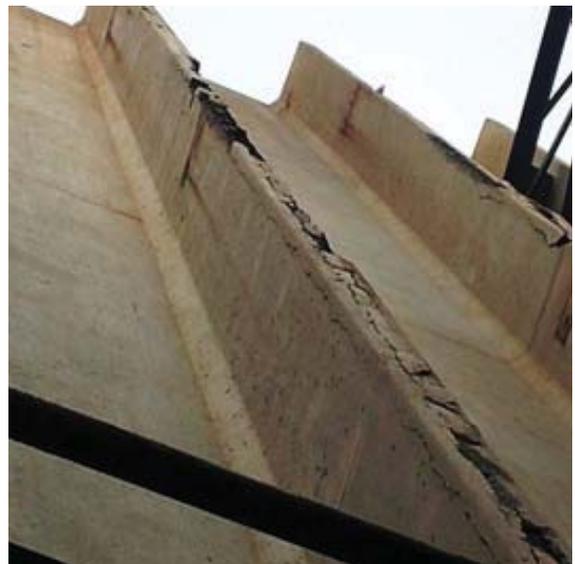
This paper describes the pathological manifestations observed in an industrial plant of galvanizing, built in 1999, using precast concrete panels and the methodology used for the recovery and rehabilitation of structures. The fence panels with double "T" geometry have the following dimensions; height 14 meters width 2.5 meters. Various pathologies were observed in the concrete panels and a photographic record of them was made for more detailed study. Initially, fronts of carbonation, attack by chloride ions, reinforcement corrosion, spalling and leaching of concrete and several cracks were identified.

Fig. 1 Pathologies presented by fence panels .
Source: Setaviso Engineering [2013]

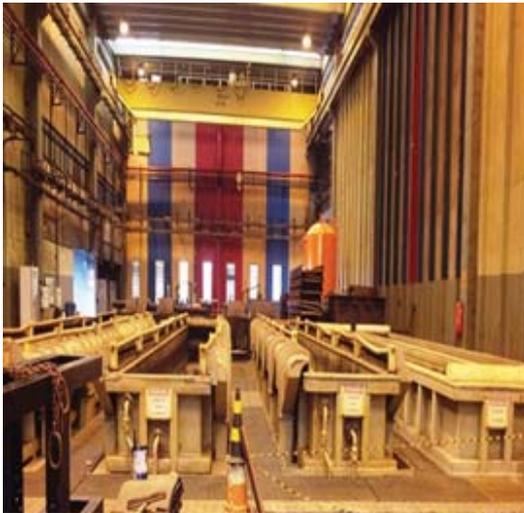
Fig.2 Hydrochloric acid tanks for pickling
Source: Setaviso Engineering [2013]

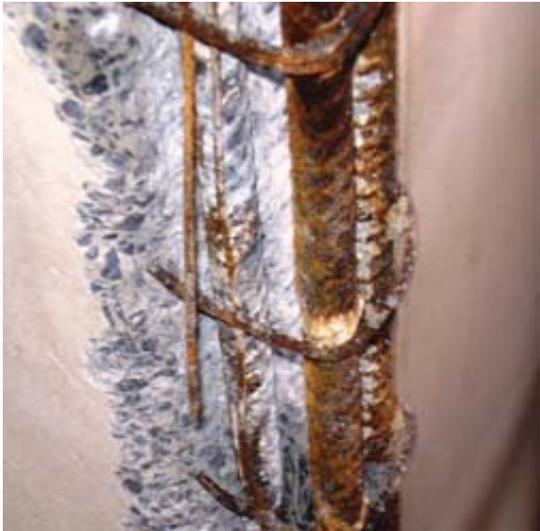
During the inspection were found a high concentration of reinforcement on the panels section. The covering thickness was below the NBR6118 and NBR9062 specifications. It was found many situations

with 4 $\theta \frac{3}{4}$ rebars concentration on the 100mm pillar section .

Fig. 3 High concentration of reinforcement, 4 rebar $\theta \frac{3}{4}$ and low reinforcement coverings (6mm) The structure is already attacked by hydrochloric acid vapors.
Source: Setaviso Engineering [2013]

Thus the low covering was also a major factor to allow chloride ions penetration and accelerate the corrosion of reinforcement. “

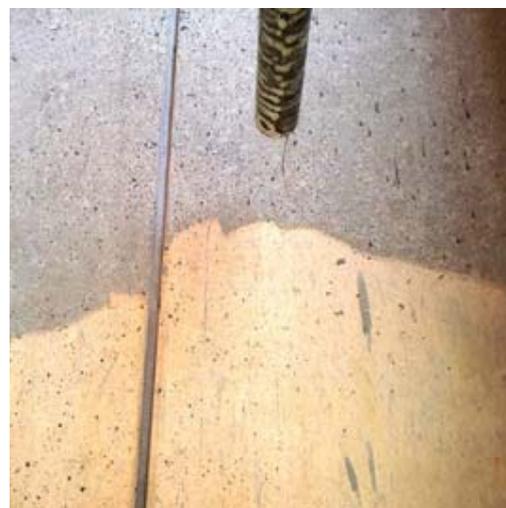
Fig. 6- First step of cleaning: washing with hot water
Source: Setaviso Engineering [2013]

- Wash all the structures with pressurized hot water 4,000 PSI (281kgf / cm²);
- Demolition of all points where the concrete showed signs of deterioration;
- Washing of structures with alkaline-based anionic surfactants, alkalis, solvents and emulsifiers concentrated detergent PH 14;
- Wash with mild biodegradable detergent and hot pressurized water 4,000 PSI;
- Treatment of armor using needle gun, wire brushes to remove all corrosion points;
- Replacement of armor that had loss of greater than 5% nominal section;
- Treatment of armor with zinc rich epoxy two component polyamide cured to provide cathodic protection to the carbon steel;
- Application of adherence to structural thixotropic epoxy adhesive slowly picks bridge;

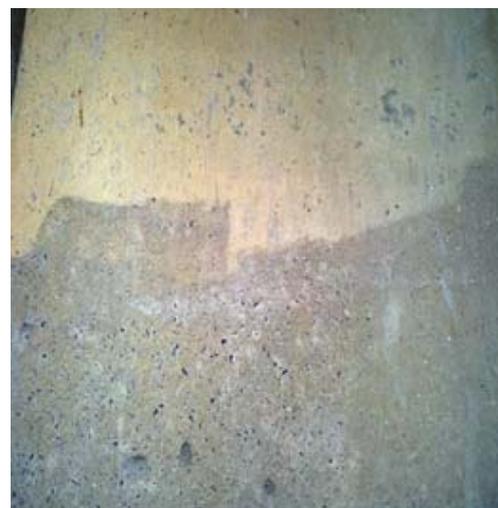
Fig. 7- Second step of cleaning: washing with pressurized water and alkaline detergent pH14.
Source: Setaviso Engineering [2013]

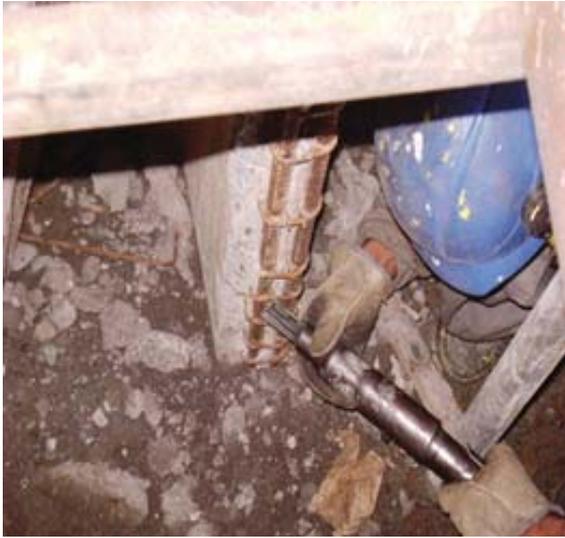
Fig. 8- Reinforcement cleaning using needle gun.
Source: Setaviso Engineering [2013]

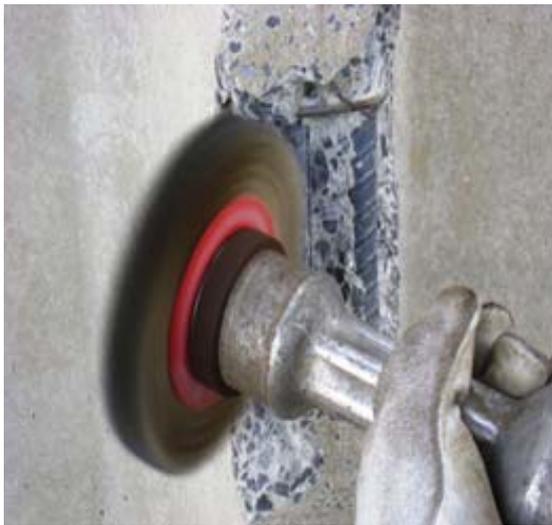
Fig. 9- Reinforcement cleaning using
steel rotating brush.
Source: Setaviso Engineering [2013]

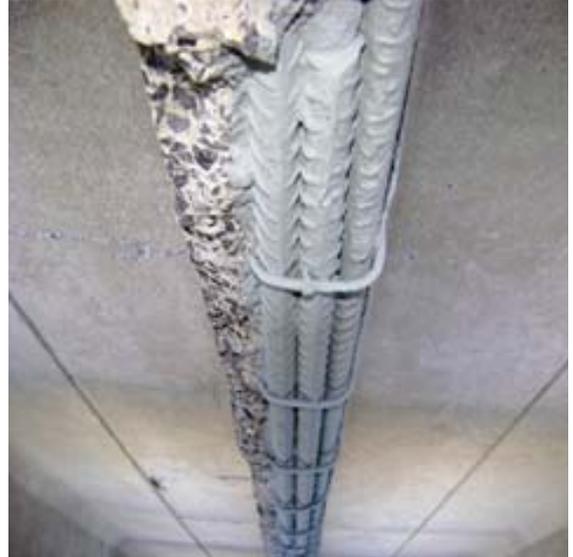
Fig. 10- Application of epoxy rich zinc for reinforcement
protection.
Source: Setaviso Engineering [2013]

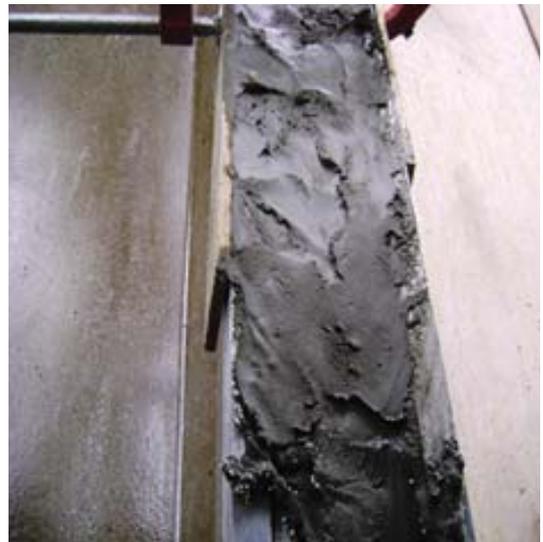
Fig. 11-Application of structural cementitious mortar for
repairs up to 7cm deeper.
Source: Setaviso Engineering [2013]

•Application of cementitious mortar for structural repairs to concrete structures with thickness 3.0 cm to 7,0cm depth application system “dry-pack”;

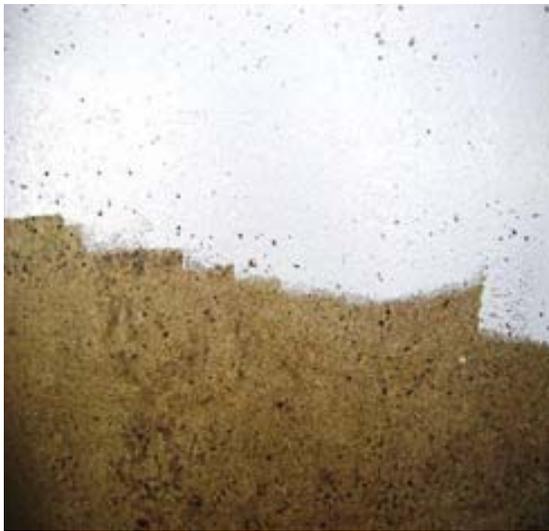
Fig. 12- Application of epoxy varnish sealer and application of intermediate coat in epoxy two component polyamide cured.

•Application of the sealing epoxy varnish, polyamide cured with appropriate viscosity to allow good penetration into concrete surfaces, plaster, masonry, cement asbestos seals these surfaces prevents excessive absorption with a dry film thickness of 50 μ ;

•Application of two intermediate coats with bi cured epoxy polyamide component, high-build, fast drying, developed to protect carbon steel and concrete in industrial exposures environment , applied dry film thickness of 150 μ ;

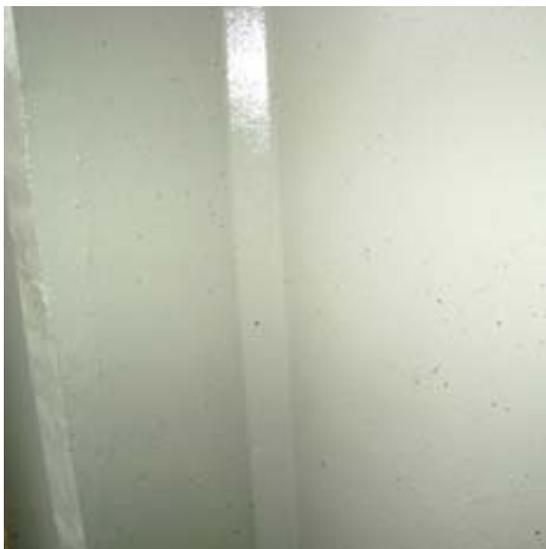
Fig. 13-Application of final coat in acrylic aliphatic polyurethane low (VOC).

•Apply a finish coat of acrylic aliphatic polyurethane high build, bi component with a low content of volatile organic compounds (Low VOC). Paints in acrylic aliphatic polyurethane has excellent weathering resistance, excellent flexibility and toughness to withstand the harshest working conditions, with dry film thickness of 100 μ
